Periodical preventative  
maintenance

Flexo Shower-toiletchair

51005199 (Standard)

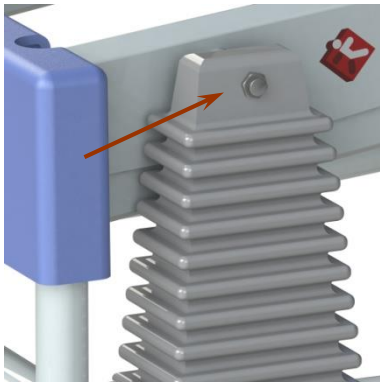
Figure 1 Bellow

1. Put the chair in a high position. Pull the bellows from the lever pin and slide them around the pump shaft. (See figure 1 Bellow)

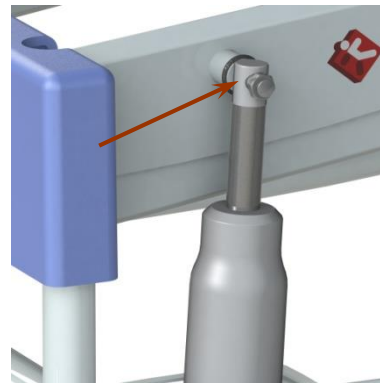
Figure 2 Pump

2. Detach the screw part. Pull the pump from the lever pin. **PLEASE NOTE: the upper frame is now loose and can go down!**

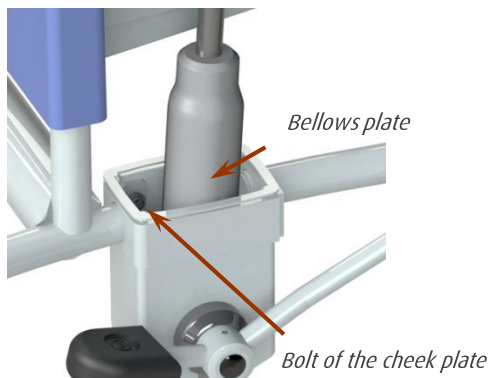
Figure 3 Bolt of the cheek plate

3. Detach the bellows at the bottom of the bellows plate pull them over the pump.

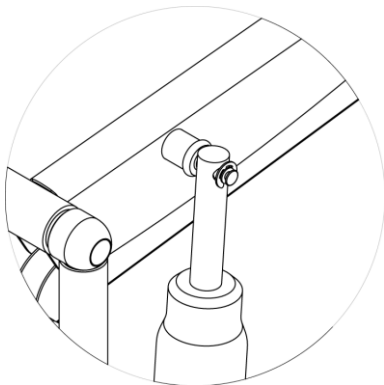
Figure 4 Pump mounting

1. Detach the bellows and slide them around the pump shaft. Remove the retaining ring.

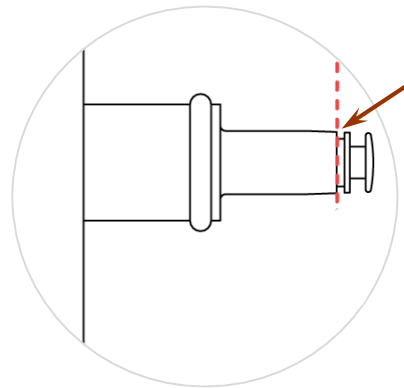
Figure 5 Hinge pin

2. Saw off the hinge pin.

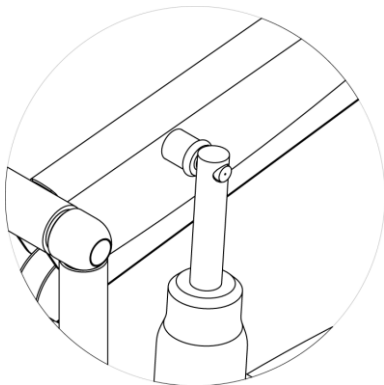
Figure 6 Hinge pin sawed

3. Mark the centre of the shaft.

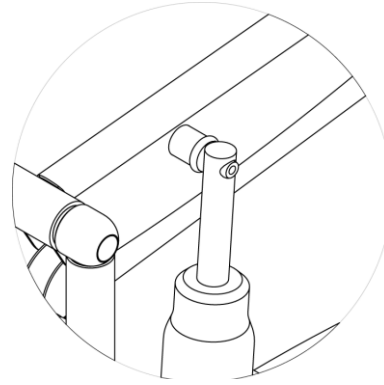
Figure 7 Hinge pin Screw thread

4. Drill a 5mm hole, at least 20mm deep, and insert tap M6 into the hole. Put the chair on its side so you can drill the hole.

5. Fit the screw part (seal with Loctite). Attach the bellows to the pin.

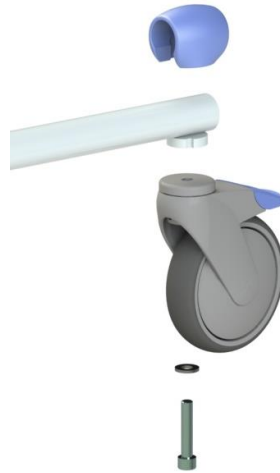
Figure 9 wheel exploded

- Check the attachment of the wheel (Tolerance)
- Check freewheel function + brakes.
- Do all four the wheels touch the floor on a flat surface? If not, check the chair right course.
- Brake lip intact?
- Check the tread.

Replace the wheels if they are damaged or worn.

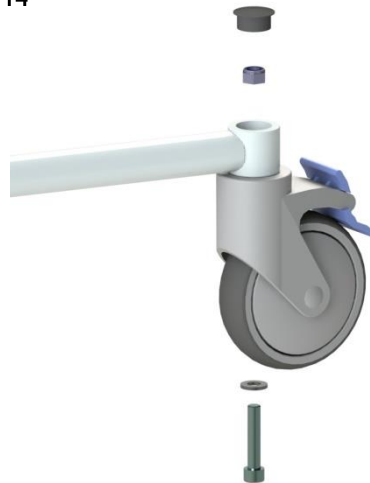
Figure 11 Wheel exploded view

- Check the attachment of the wheel (Tolerance)
- Check freewheel function + brakes.
- Do all four the wheels touch the floor on a flat surface? If not, check the chair right course.
- Brake lip intact?
- Check the tread.

Replace the wheels if they are damaged or worn.

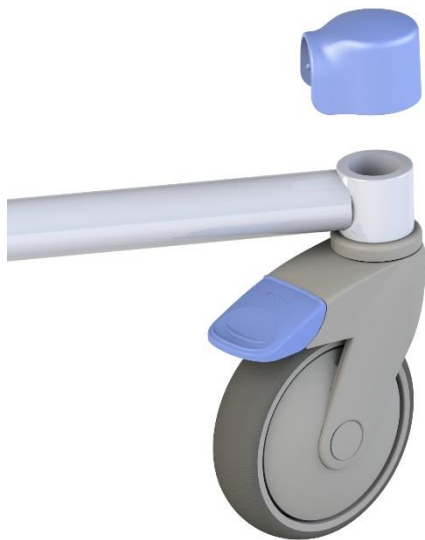
Figure 12 Cover

Chairs that are made before July 2014 are equipped with steel wheel clots. For those clots we have a cover to protect against damage.

Place the cover on the steel wheel clots, if it is not done already.

- Remove the decorative plug
- Is there corrosion on the wheel clots?
- Remove loose corrosion with a wirebrush.
- Treat the wheel clots with rust converter Noverox.
- Paint the wheel clots.
- Let the paint dry.
- Place the cover over the wheel clots.

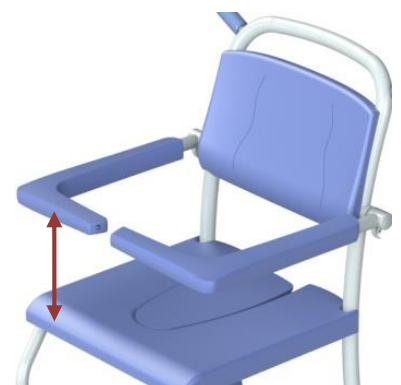
Figure 13 Armrest

- Inspect its functioning, and check for any damage, corrosion.
- Check its room for motion, measured at the front point (replace if it is more than 4 cm.) (See figure 13).
- Always treat corrosion.
- Are the arm supports evenly positioned?
- Slide PUR back if necessary.

- The stainless-steel (A2) bolts should always be replaced by M8x12 DIN912 Zincflake.
- Fastly secure bolts. (See figure 14)

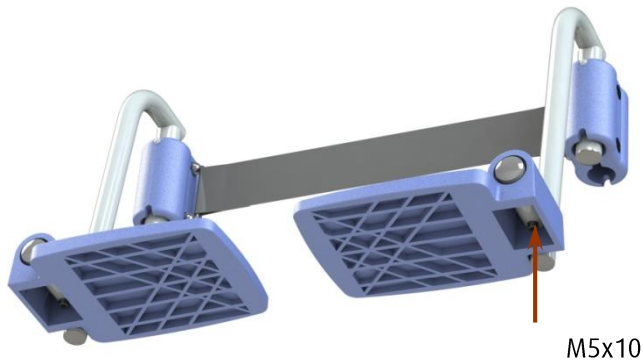
Figure 15 Foot rest

- Check for any damage.
- Fold up foot plates (should be stiff and stay upright). (They should remain in the folded position, without falling back automatically)
- Are the foot plates evenly fitted and slanting upwards a little towards the middle?
- Check M5x10 (bottom of plate), and replace stainless-steel bolts with ELVZ 8.8 bolts. (See figure 15)
- Check if the footrest clamps are tight

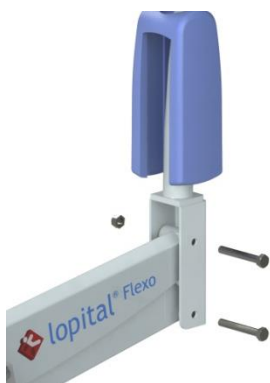
Figure 16 Disassemble chair frame

1. Lift the PUR hinge cover and detach the nuts. Remove the bolts and remove the chair frame from the undercarriage.

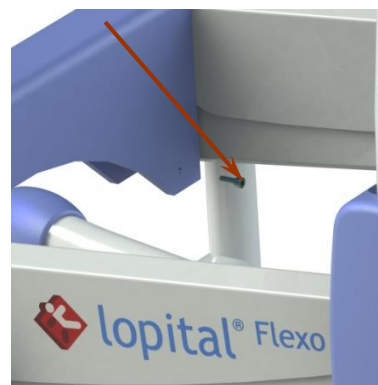
Figure 17 Disassemble frontcap

2. Remove the front cover by detaching the bolts at the back of the cover.

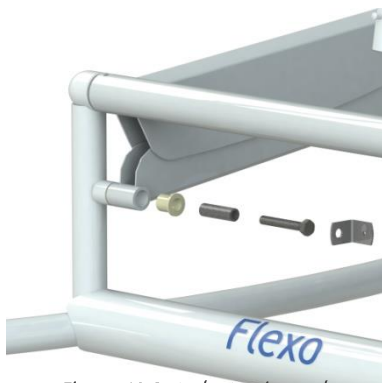
Figure 18 Detach steering rod

3. Detach the steering rod.

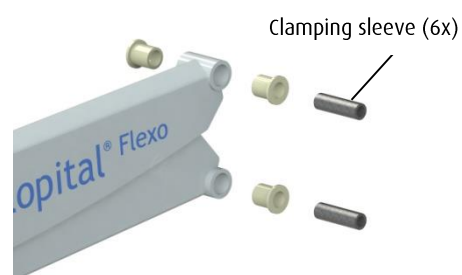
Figure 19 clamping sleeve and bearings

If the chair can no longer be moved up and down smoothly, the clamping sleeve (Art. No. 70519924) is worn or rusted and should be replaced. When replacing a clamping sleeve, you should also replace the bolts and bearings!

4. Remove the clamping sleeve and bearings (they are usually very tight, because of plaster or rust).

5. Fit the new plastic sleeve bearings and the new clamping sleeves. Put the steering rod back (seal bolt with Loctite strong). Refit the chair frame and fit the bolts and lock nuts.
