Reflex PM Checklist

1. General condition of the chair

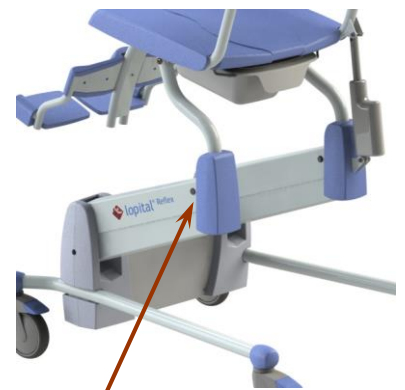
Figure 1 Chair supports

- Visually check all painted parts for damage and corrosion. Touch up if necessary. _____
- Chairs before production year 2005 have to be checked extra good at corrosion on the seat carriers (under the PUR) and corrosion on the chassis (especially between the square turrets where the batteries are, don't remove the caps). (See figure 1 and 2). Remove the actuator cap. _____

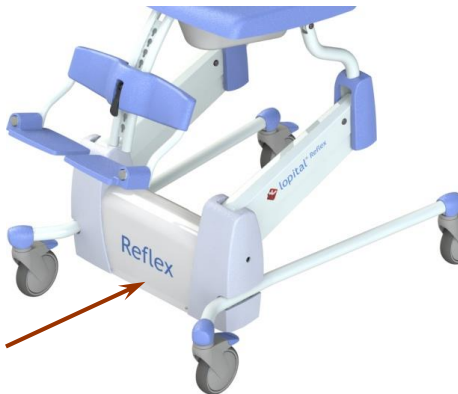
Figure 3 Cap

1. Put the chair in a high position. Unscrew screws (4x) and lift cover. (See figure 3)

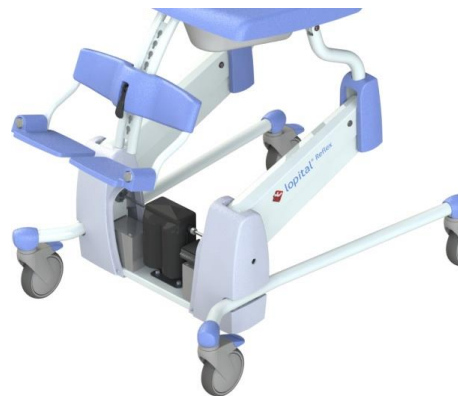
Figure 4 Batteries

2. Disconnect battery cables (the red plus pole first)

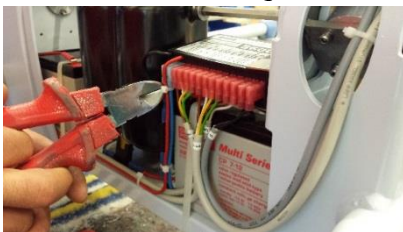
Figure 6 Control

1. Cut the tyraps of the cables so that the cables are disconnected. Please note that the battery cables are not connected, the controller is energized.

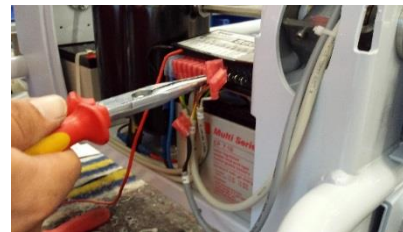
Figure 7 Disassemble plugs

2. Remove the plugs of the controller.

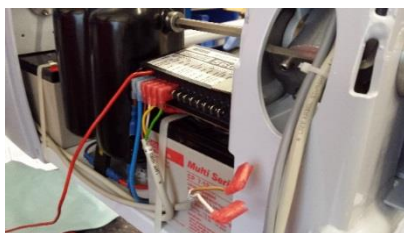
Figure 10 Connect control

5. Place the control back and connect the control. Pay attention to the coding of the cables (M.E.D.A.B.). Squeeze the shells of the connectors firmly with pliers.

6. Connect the battery cables. The red positive terminal last. Replace the cover and tighten the screws.

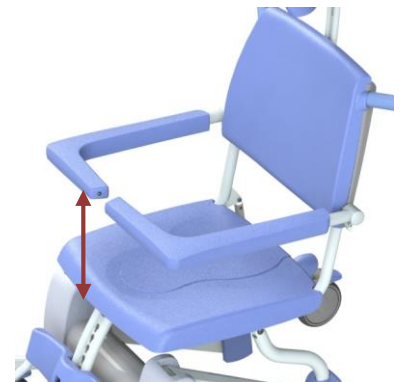
Figure 21 Armrest

- Inspect its functioning, and check for any damage, corrosion.
- Check its room for motion, measured at the front point (replace if it is more than 4 cm.) (See figure 21).
- Always treat corrosion.
- Are the arm supports evenly positioned?
- Slide PUR back if necessary.

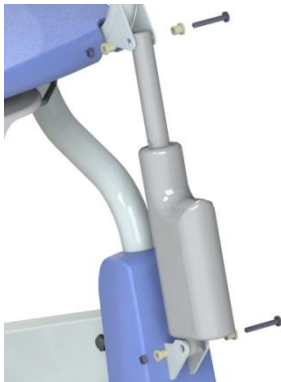
Figure 28 Tilt actuator

- Check actuator for any damage.
- Check cable for any damage.
- Check bolts + nuts.

- Cut tiwrap.
- Unscrew screws.
- Detach plastic bearings.
- Detach actuator (NB: cable).
- Fit new actuator.
- Fit sleeve bearings.
- Tighten screws.
- Fit new tiwrap.
- Test tilting function.
